Approval of 50, 65 and 75mm Reo Bar Chair Blocks

Test Report

To	C O D	Report No.	MTS-39591 C O D
Order No.	COD - lester michel <lmfour@bigpond.com>	Reference No.	LP22-1444
		Issue Date	19/08/2022
		Test Date	19/08/2022

Reo Bar Chair Blocks were received for the purpose of load testing as per AS/NZS 2425-2015 Clause 6 and load testing to failure.

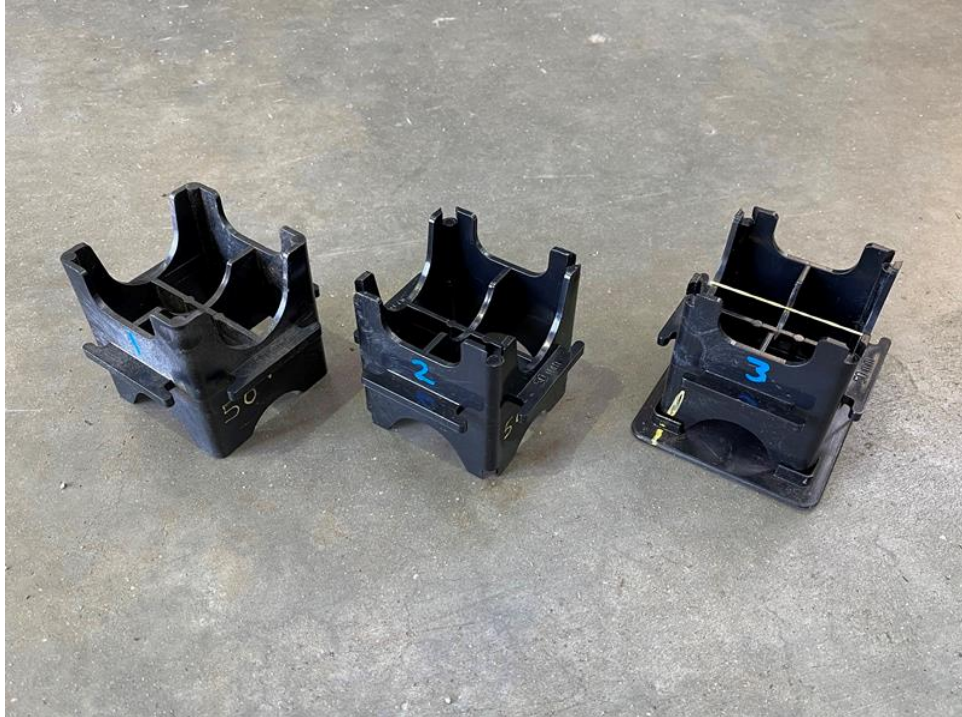
As Received - 01 - 02 - 03

ID	Item/Heat No.	Dimensions/Type/Details
LP22-1444/01	-	Reo Bar Chair Block - 50mm
LP22-1444/02	-	Reo Bar Chair Block - 50mm
LP22-1444/03	-	Reo Bar Chair Block - 50mm with bottom plate

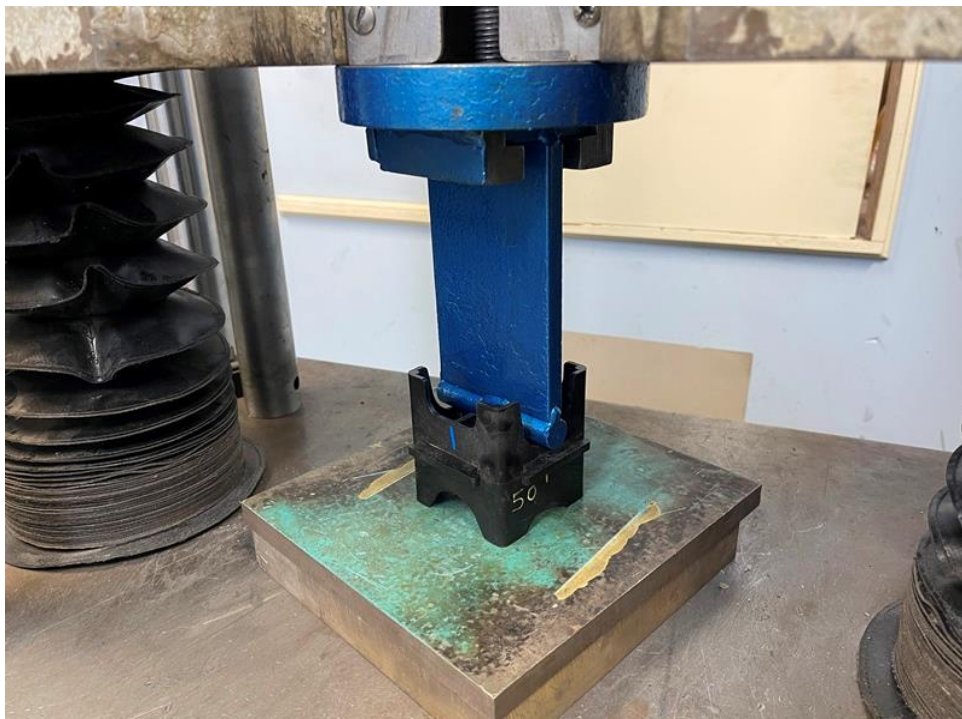
Test Setup - 01 - 02 - 03

- The bar chair block was placed on a flat steel plate.
- The load was applied by way of a 24 mm diameter plain round steel pin for strength grade >300.
- A 20 kg Pre-Load was applied on the bar chair block, at which the datum point was established.
- The load was increased at a uniform rate to 300 kg, and held for 2 min. The deflection under load was measured.
- The load was reduced to 20 kg, and the permanent set was measured.

- The bar chair block was placed on a flat steel plate.
- The load was applied by way of a 24 mm diameter plain round steel pin for strength grade >300.
- The load was increased at a uniform rate until failure occurred. The failure load and mode of failure was noted.

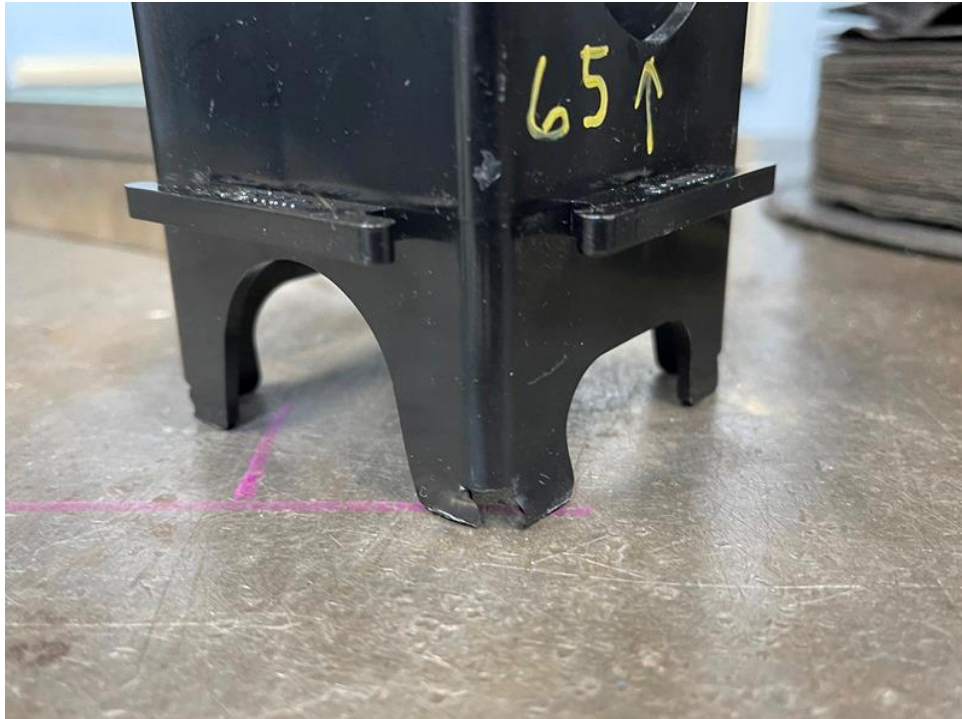
Typical Base Feet Failure

Specimen ID	Observations
LP22-1444/01	Failure Load: 1600 kg Failure Mode: The bar chair block cracked in half.
LP22-1444/02	Failure Load: 1611 kg Failure Mode: Deformation of the bar chair block's base feet was observed.
LP22-1444/03	Failure Load: 1713 kg Failure Mode: Deformation of the bar chair block's base feet was observed.

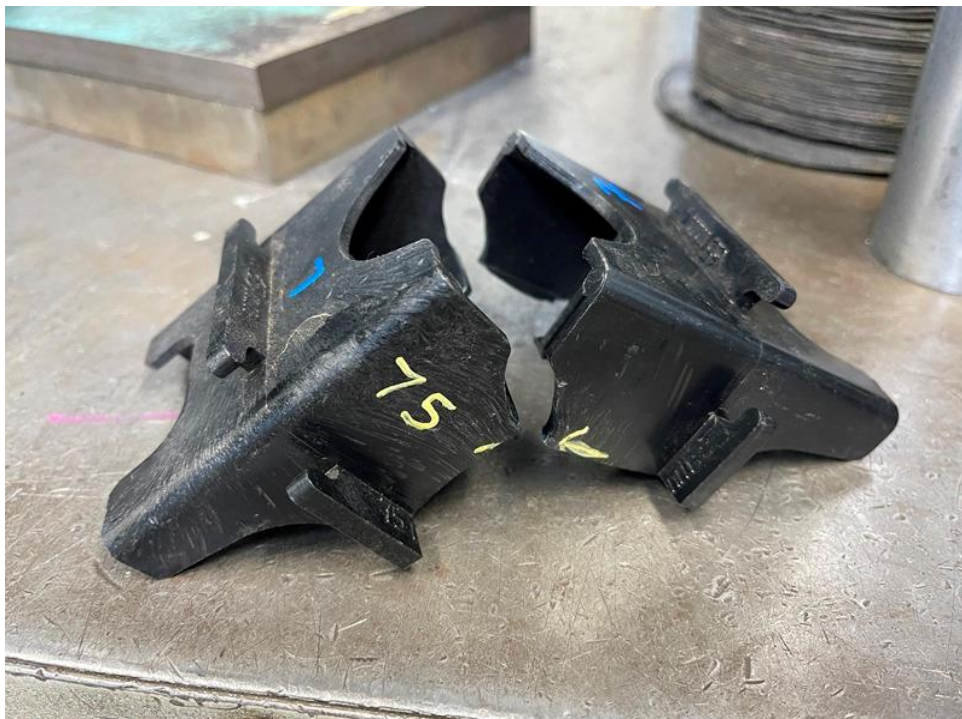
Typical Crack Failure

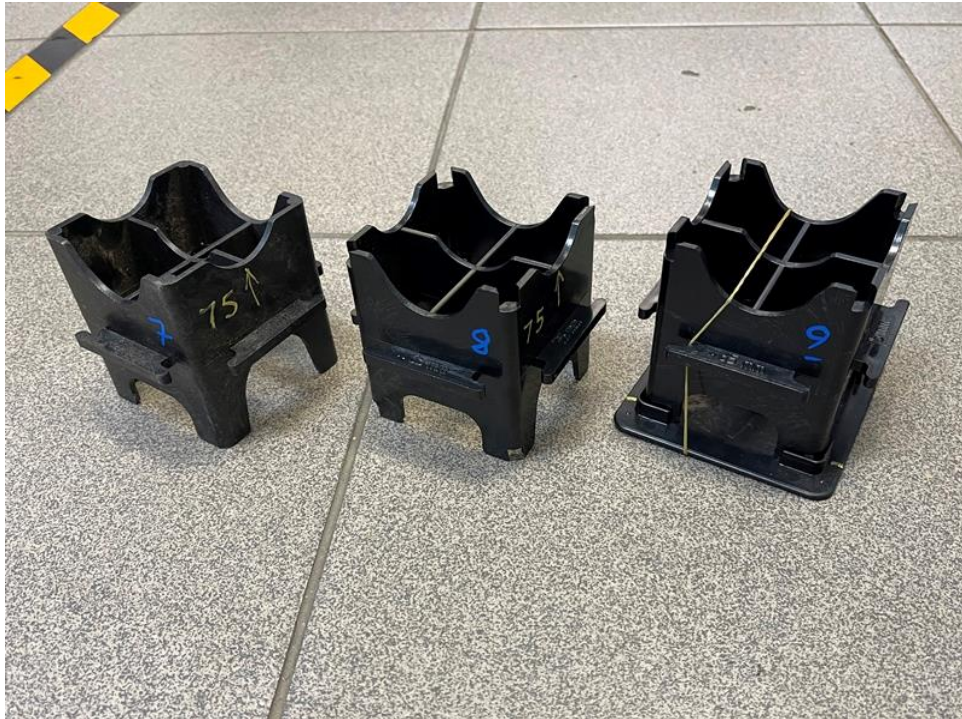
As Received - 07 - 08 - 09

ID	Item/Heat No.	Dimensions/Type/Details
LP22-1444/07	-	Reo Bar Chair Block - 75mm
LP22-1444/08	-	Reo Bar Chair Block - 75mm
LP22-1444/09	-	Reo Bar Chair Block - 75mm with bottom plate

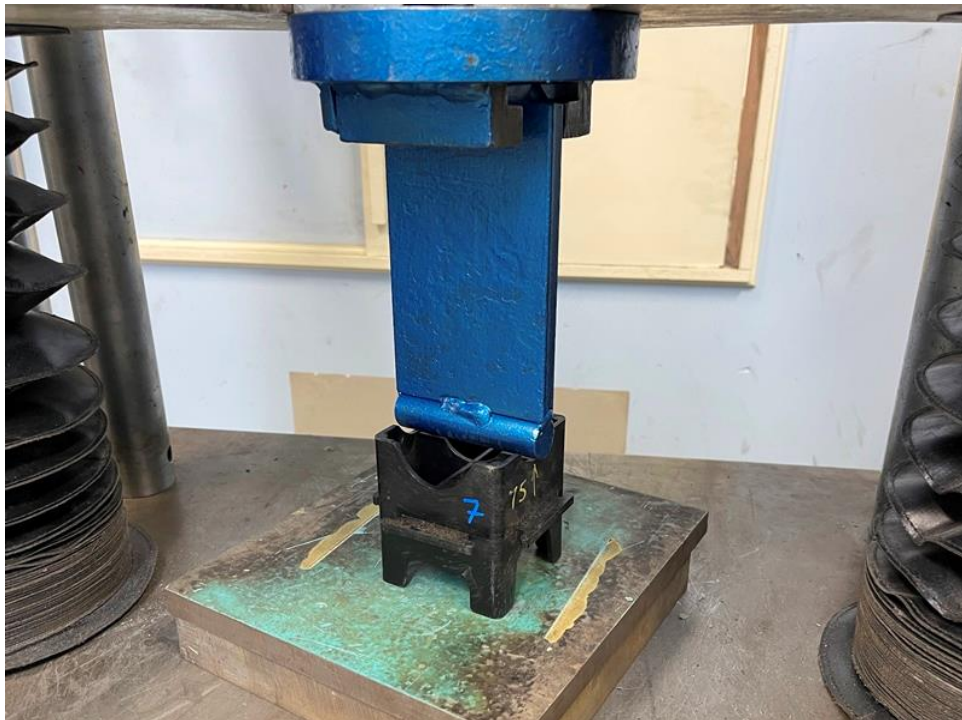
Test Setup - 07 - 08 - 09

- The bar chair block was placed on a flat steel plate.
- The load was applied by way of a 24 mm diameter plain round steel pin for strength grade >300.
- A 20 kg Pre-Load was applied on the bar chair block, at which the datum point was established.
- The load was increased at a uniform rate to 300 kg, and held for 2 min. The deflection under load was measured.
- The load was reduced to 20 kg, and the permanent set was measured.

- The bar chair block was placed on a flat steel plate.
- The load was applied by way of a 24 mm diameter plain round steel pin for strength grade >300.
- The load was increased at a uniform rate until failure occurred. The failure load and mode of failure was noted.

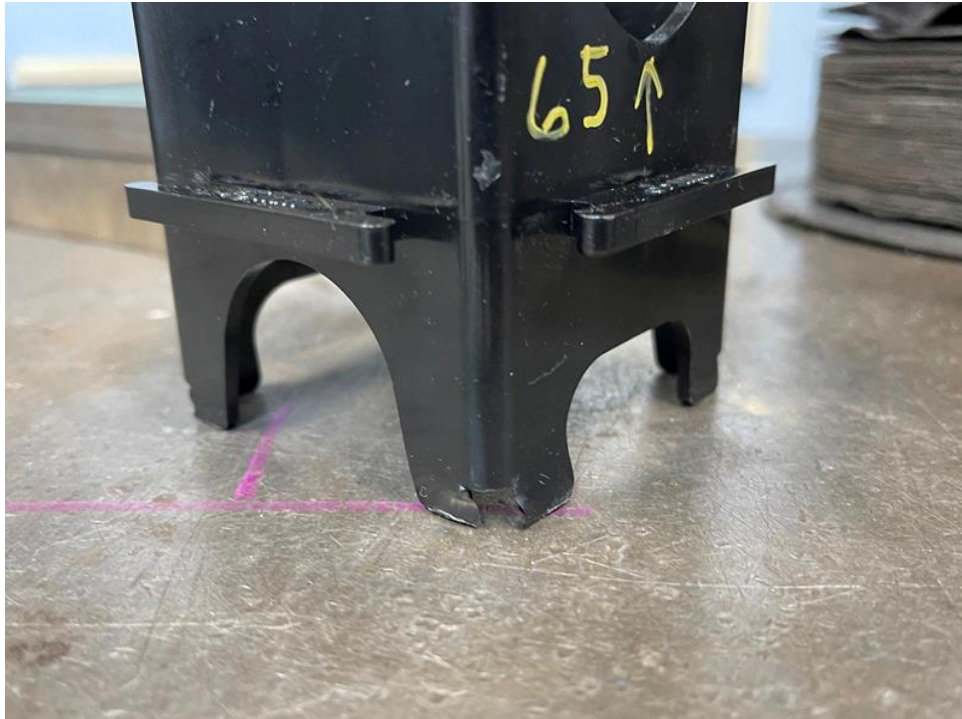
Typical Base Feet Failure

Specimen ID	Observations
LP22-1444/07	Failure Load: 1417 kg Failure Mode: The bar chair block cracked in half.
LP22-1444/08	Failure Load: 1274 kg Failure Mode: Deformation of the bar chair block's base feet was observed.
LP22-1444/09	Failure Load: 1346 kg Failure Mode: Deformation of the bar chair block's base feet was observed.

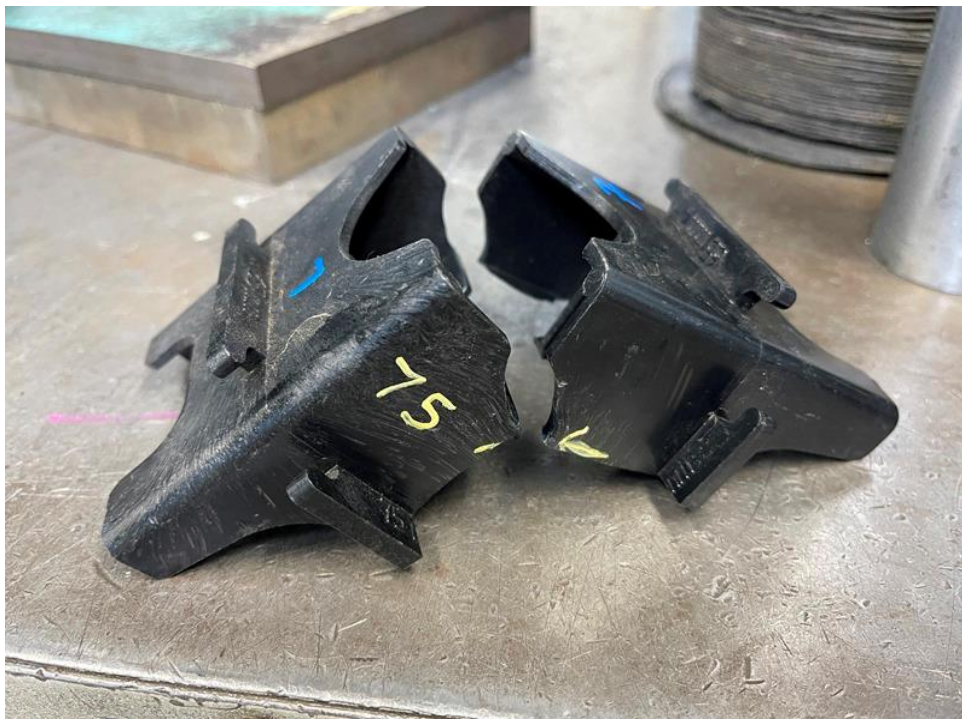
Typical Crack Failure
